**Flood Control Project Maintenance  
Levee Inspections**  
**LMA District Cover Sheet**  
**Spring 2017 Levee Inspection Results**

**Sacramento River West Side Levee District**

| Waterway | | | Bank | Unit Miles |
|--|---|---|---|---|
| Unit No. 01 Sacramento River | | | Right | 49.64 |

**Levee Inspection Report By Mile - Spring 2017**

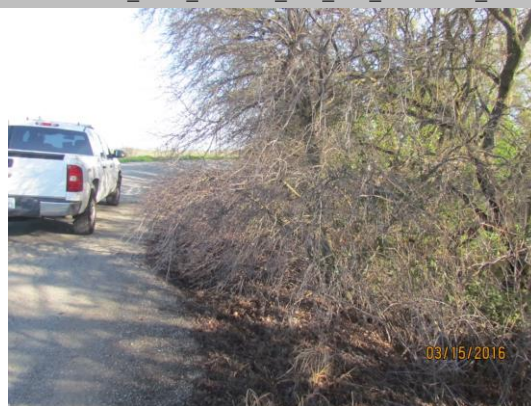
Photo 1 of 1 : SP\_2017\_NA0016\_435\_104\_20170320\_00052.jpg

View of the tree branches on the waterward side of the levee looking upstream. Spring 2016.

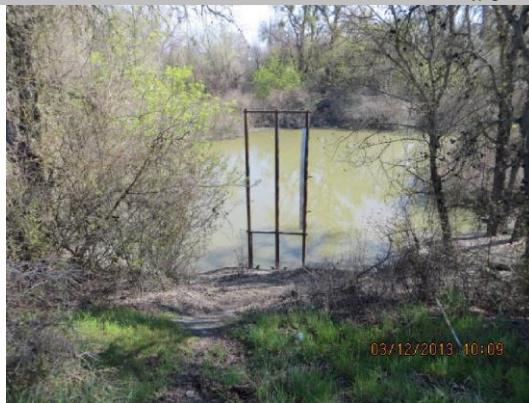
Photo 2 of 3 : UCIP\_SP\_2017\_10087\_17234.jpg

FS\_ID:10087  
DS\_ID:20224  
EP\_NO: N/A  
Repair Type: Non-Urgent  
Crossing Status: Found  
UCIP Comments: Headwall on WS undermined about 3-4-feet.  
FIELD\_STRUCT\_DESC: 1 of 3: 36-inch steel drainage pipe through levee 30.0 feet below crown. Flap gate on the waterward end. 24-inch pipe sleeved through the 36-inch pipe. Annular space between pipes grouted. Pumps in pumphouse with walkway on LS toe. Originally included in the 1960 O&M manual.  
FS Date: 3/12/2013

Air vents at outlet on WS toe.

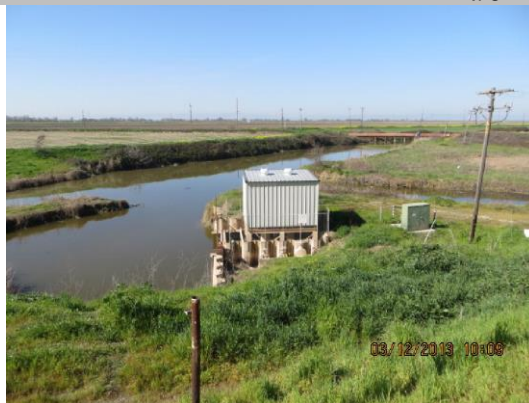
Photo 1 of 3 : UCIP\_SP\_2017\_10085\_17227.jpg

Pump house on LS toe.

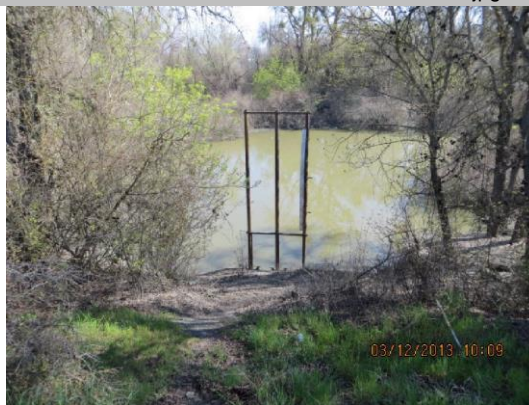
Photo 2 of 3 : UCIP\_SP\_2017\_10085\_17226.jpg

Air vents on pipes at WS toe.

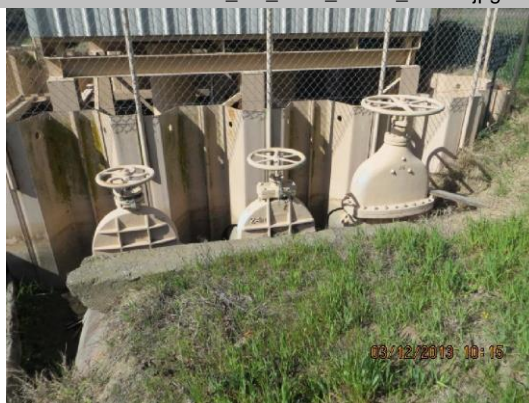
Photo 3 of 3 : UCIP\_SP\_2017\_10085\_17225.jpg

Slide gates at pumphouse on LS toe.

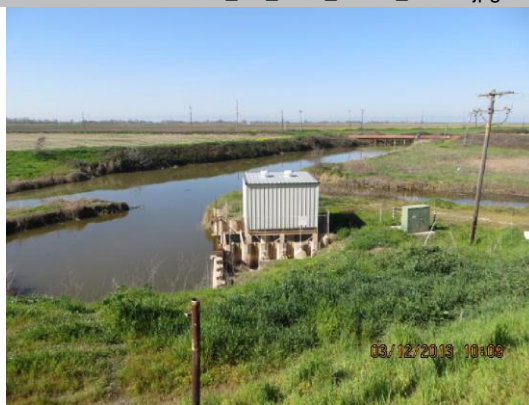
Photo 1 of 3 : UCIP\_SP\_2017\_10910\_18185.jpg

Pumphouse on LS toe.

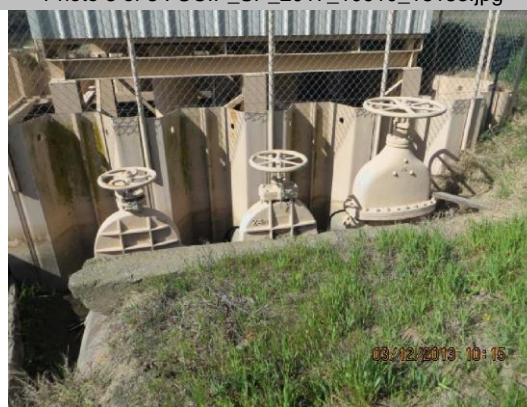
Photo 3 of 3 : UCIP\_SP\_2017\_10910\_18183.jpg

Slide gates at pumphouse on LS toe.

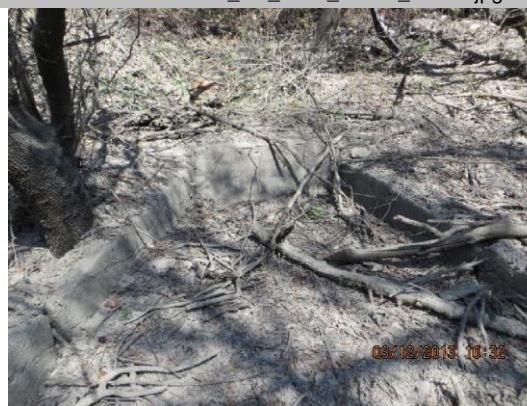
Photo 1 of 1 : UCIP\_SP\_2017\_10088\_17237.jpg

| FS_ID:10088<br>DS_ID:20327<br>EP_NO: N/A<br>Repair Type: No Action Needed<br>Crossing Status: Found<br>UCIP Comments:<br>FIELD_STRUCT_DESC: *ABANDONED* 42-inch pipe through levee<br>28.5 feet below crown. Abandoned in place by plugging with concrete.<br>Headwall on WS toe.Originally included in the 1960 O&M manual.<br>FS Date: 3/12/2013 | | | | | |

Concrete headwall visible on WS toe.

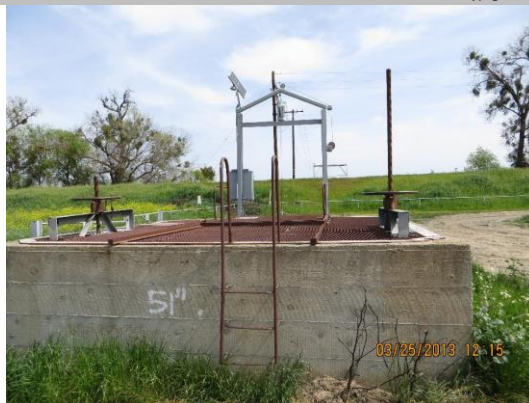
Photo 1 of 3 : UCIP\_SP\_2017\_10103\_17262.jpg

| FS_ID:10103<br>DS_ID:20226<br>EP_NO: 1331<br>Repair Type: Non-Urgent<br>Crossing Status: Found<br>UCIP Comments: There is no gate in the slide gate at the concrete distribution box off the landside toe. This may not be an issue as there is a slide gate at the WS toe.<br>FIELD_STRUCT_DESC: 54-inch corrugated metal irrigation pipe through levee 28.0 feet below crown. Vertical pumps on pile structure in the stream, walkway to pumps. Flap gates from pumps and slide gate inside a 7'X10-foot concrete surge box on the waterward side, 1948 installation. 15'X18-foot concrete distribution box 150-feet off landside toe with slide gate. (Permit No. 1331, 1948). Included in 1960 O&M manual.<br>FS Date: 3/25/2013 7:36:51 AM | | | | | |

Concrete distribution box on 150-feet off landside toe.

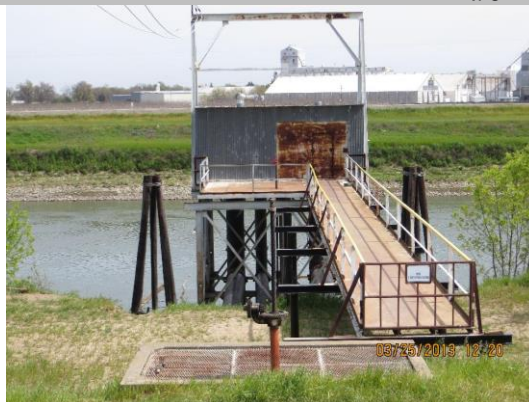
Photo 2 of 3 : UCIP\_SP\_2017\_10103\_17261.jpg

Pumping plant with concrete surge box and slide gate in foreground-off WS toe.

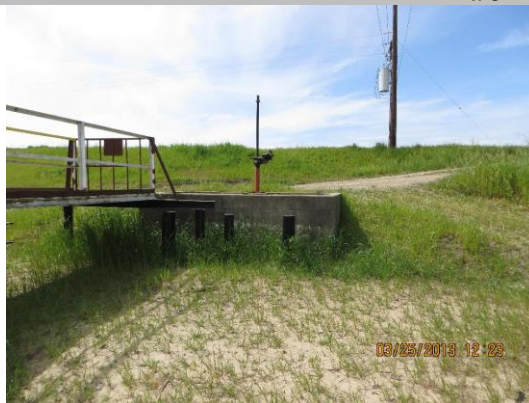
Photo 3 of 3 : UCIP\_SP\_2017\_10103\_17260.jpg

Vents for 3 pipes entering surge box on WS toe.

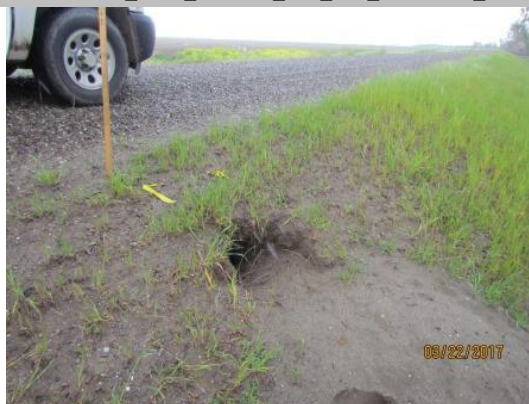
Photo 1 of 1 : SP\_2017\_NA0016\_435\_206\_20170417\_00332.jpg

| Burrow on waterside levee shoulder. | | | | | |

Burrow on waterside levee shoulder. Spring 2017.

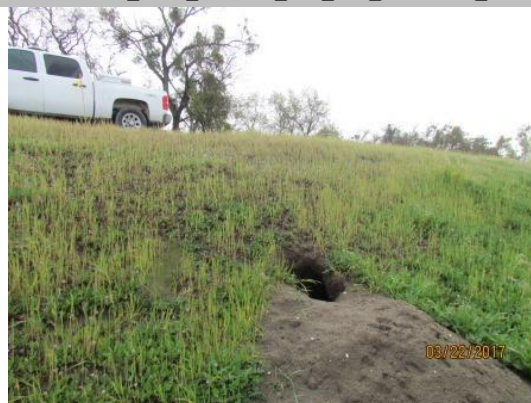
Photo 1 of 1 : SP\_2017\_NA0016\_435\_211\_20170417\_00333.jpg

| Large burrow hole on lanside levee slope. | | | | | |

Large burrow hole on lanside levee slope. Spring 2017.

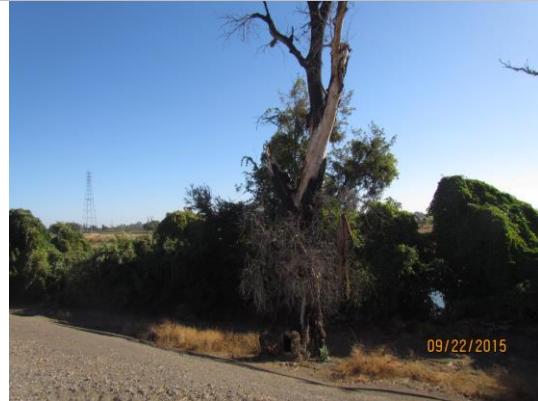
Photo 1 of 1 : SP\_2017\_NA0016\_435\_82\_20170320\_00037.jpg

View of the dying tree on the waterward side of the levee. Monitor trees that could pose a threat to the integrity of the levee. Fall 2015.

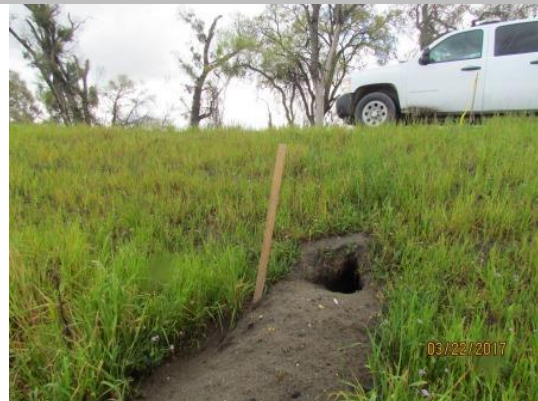
Photo 1 of 1 : SP\_2017\_NA0016\_435\_212\_20170417\_00334.jpg

| Large burrow hole on lanside levee slope. | | | | | |

Large burrow hole on landside levee slope. Spring 2017.

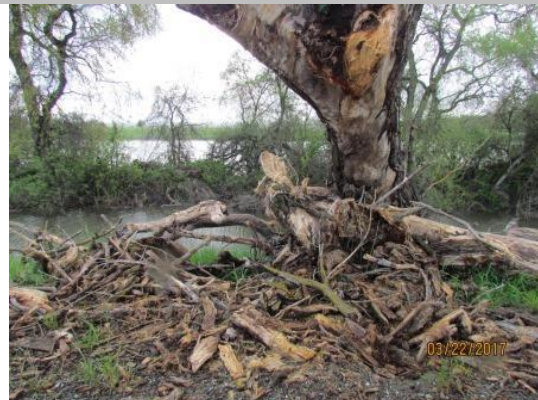
Photo 1 of 2 : SP\_2017\_NA0016\_435\_84\_20170417\_00335.jpg

| Fallen tree on waterside levee slope. | | | | | |

View of fallen tree on waterside slope, looking towards river. Spring 2017.

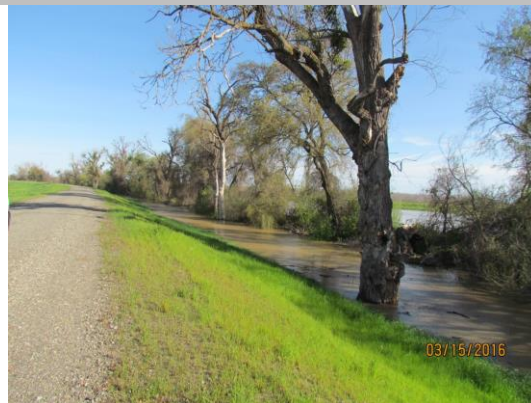
Photo 2 of 2 : SP\_2017\_NA0016\_435\_84\_20170320\_00039.jpg

| Fallen tree on waterside levee slope. | | | | | | |

View of the tree on the waterward side of the levee looking upstream.  
Spring 2016.

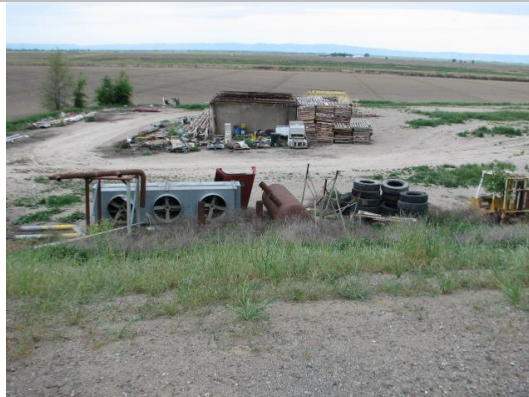
Photo 1 of 2 : SP\_2017\_NA0016\_435\_1550\_20170320\_00113.jpg

Pieces of machinery and debris at the levee toe. Spring 2014

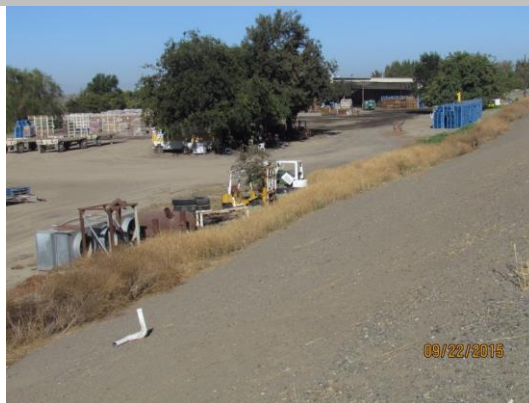
Photo 2 of 2 : SP\_2017\_NA0016\_435\_1550\_20170320\_00114.jpg

View of the machinery along the landward levee toe looking upstream. Fall 2015.

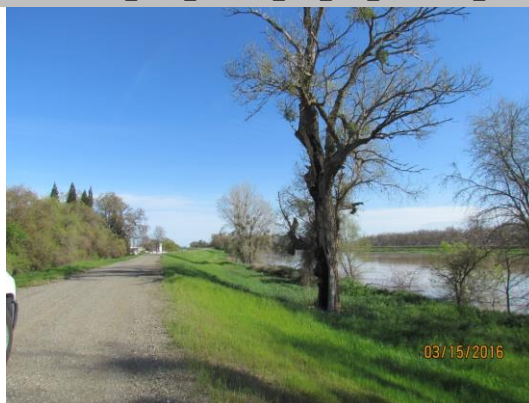
Photo 1 of 1 : SP\_2017\_NA0016\_435\_150\_20170320\_00075.jpg

| Monitor trees that pose a future threat to the integrity of the levee. | | | | | |

View of the tree on the waterward side of the levee looking upstream. Spring 2016.

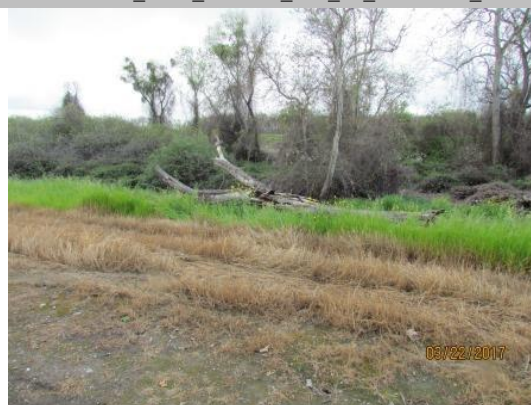
Photo 1 of 2 : SP\_2017\_NA0016\_435\_86\_20170417\_00336.jpg

| Fallen tree on waterside levee slope. | | | | | |

Fallen tree on waterside levee slope. Spring 2017.

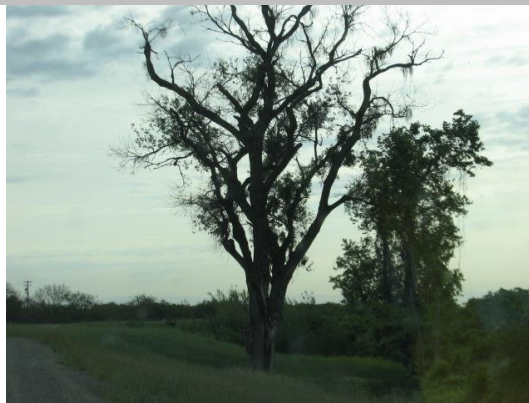
Photo 2 of 2 : SP\_2017\_NA0016\_435\_86\_20170320\_00040.jpg

| Fallen tree on waterside levee slope. | | | | | | |

Monitor trees that pose a future threat to the integrity of the levee.  
Spring 2014

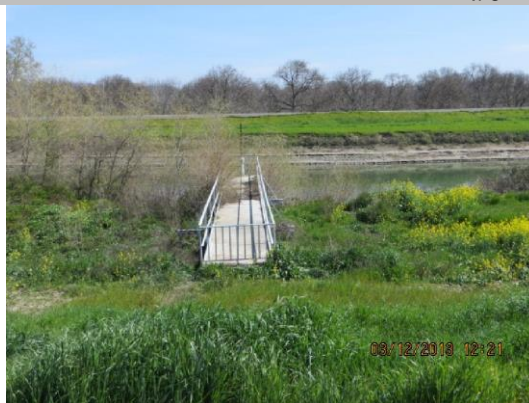
Photo 1 of 3 : UCIP\_SP\_2017\_10125\_17283.jpg

Steel walkway on WS berm with Slide gate actuator.

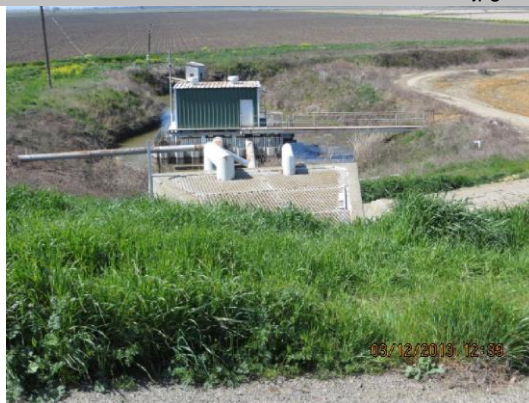
Photo 2 of 3 : UCIP\_SP\_2017\_10125\_17282.jpg

Pumphouse at LS toe and concrete riser on LS shoulder.

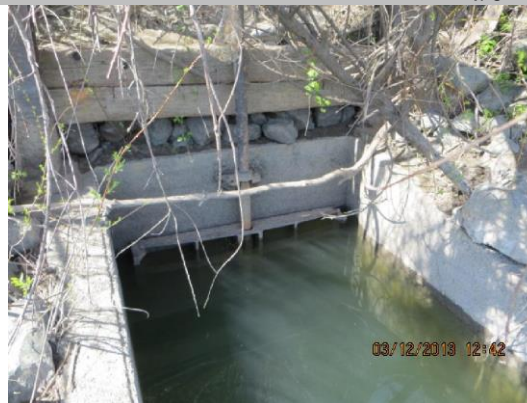
Photo 3 of 3 : UCIP\_SP\_2017\_10125\_17281.jpg

Slide gate at outlet at river side.

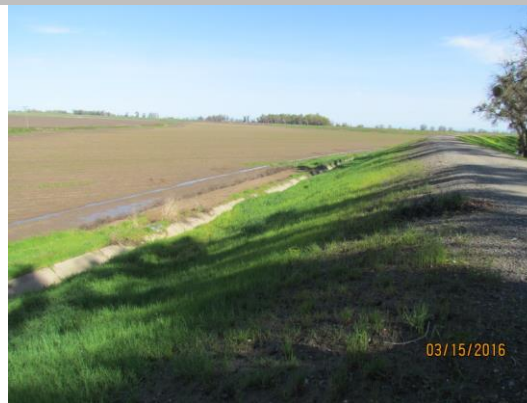
Photo 1 of 1 : SP\_2017\_NA0016\_435\_8\_20170320\_00008.jpg

| Concrete lined ditch runs along the levee toe. | | | | | |

View of the ditch on the landward side of the levee looking upstream.  
Spring 2016.

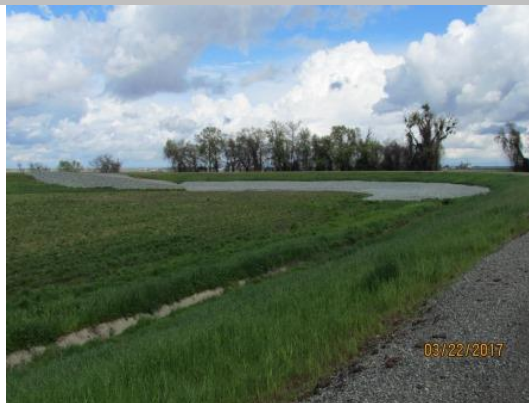
Photo 1 of 4 : SP\_2017\_NA0016\_435\_153\_20170417\_00337.jpg

| Seepage area has been staked and noted by LMA. Monitor seepage site. USACE placed seepage berm at the beginning of March, 2017. | | | | | |

View of seepage berm and ramp placed on landside levee slope by USACE on March 1, 2017.

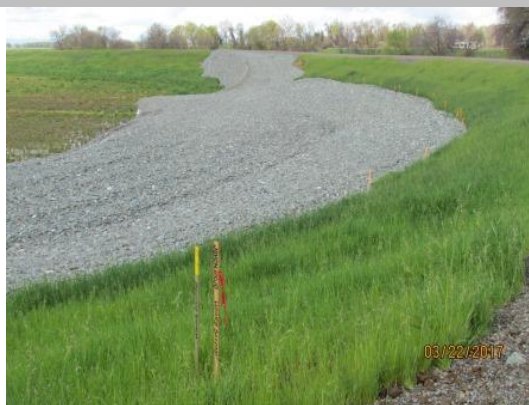
Photo 2 of 4 : SP\_2017\_NA0016\_435\_153\_20170417\_00338.jpg

Additional view of seepage berm and ramp placed on landside levee slope by USACE on March 1, 2017.

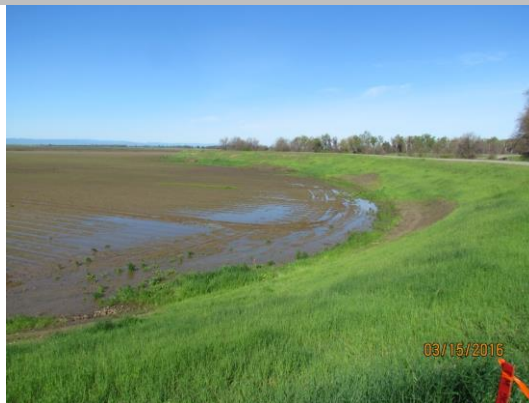
Photo 3 of 4 : SP\_2017\_NA0016\_435\_153\_20170320\_00079.jpg

View of the seepage on the landward side of the levee looking upstream. Spring 2016.

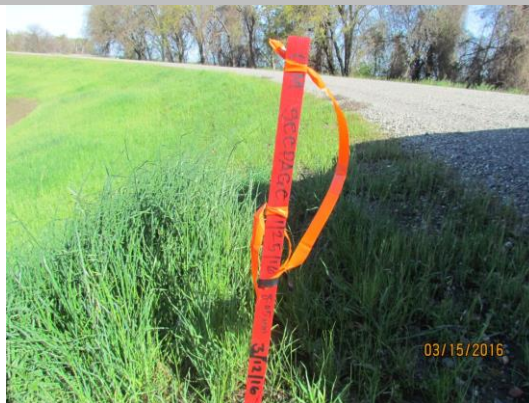
Photo 4 of 4 : SP\_2017\_NA0016\_435\_153\_20170320\_00080.jpg

| Seepage area has been staked and noted by LMA. Monitor seepage site. USACE placed seepage berm at the beginning of March, 2017. | | | | | | |

LMA has staked seepage area and are monitoring the situation.

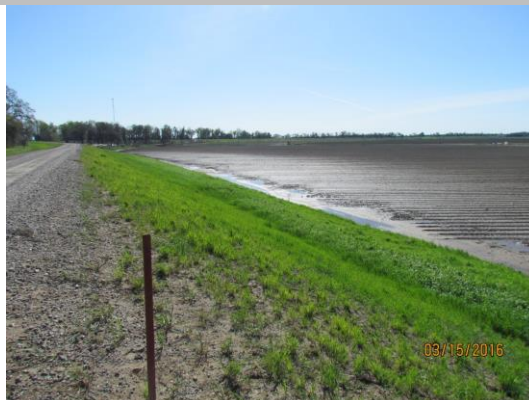
Photo 2 of 2 : SP\_2017\_NA0016\_435\_111\_20170320\_00063.jpg

| Seepage area has been staked and noted by LMA. Monitor seepage site. | | | | | |

View of the seepage on the landward side of the levee looking downstream. Spring 2016.

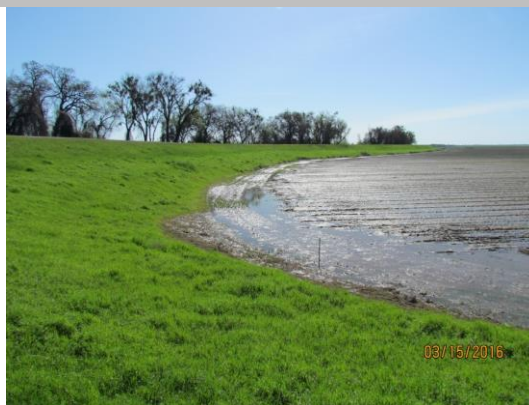
Photo 2 of 3 : SP\_2017\_NA0016\_435\_152\_20170320\_00077.jpg

| Seepage area has been staked and noted by LMA. Monitor seepage site. | | | | | |

View of the seepage on the landward side of the levee looking downstream. Spring 2016.

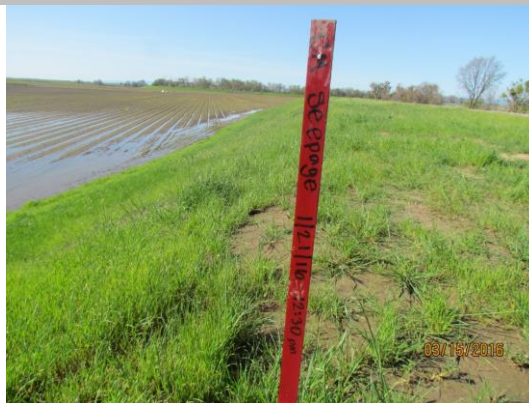
Photo 3 of 3 : SP\_2017\_NA0016\_435\_152\_20170320\_00078.jpg

LMA monitoring stake for the seepage. Spring 2016.

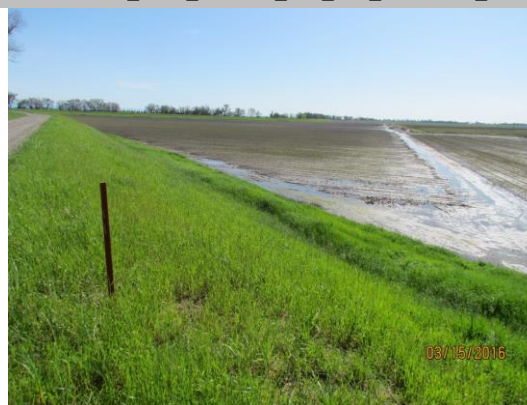
Photo 1 of 2 : SP\_2017\_NA0016\_435\_156\_20170320\_00082.jpg

| Seepage area has been staked and noted by LMA. Monitor seepage site. | | | | | |

View of the seepage on the landward side of the levee looking downstream. Spring 2016.

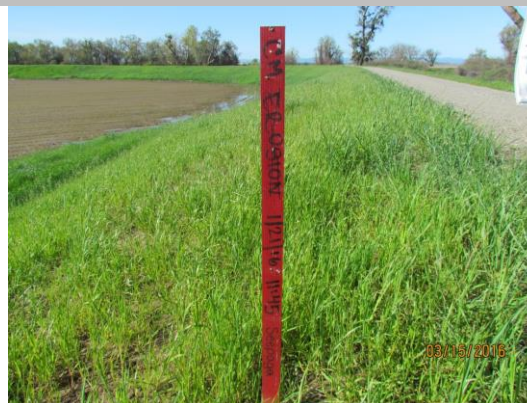
Photo 2 of 2 : SP\_2017\_NA0016\_435\_156\_20170320\_00083.jpg

Stake marks the seepage site on the levee prism and is placed on the landward shoulder. Spring 2016.

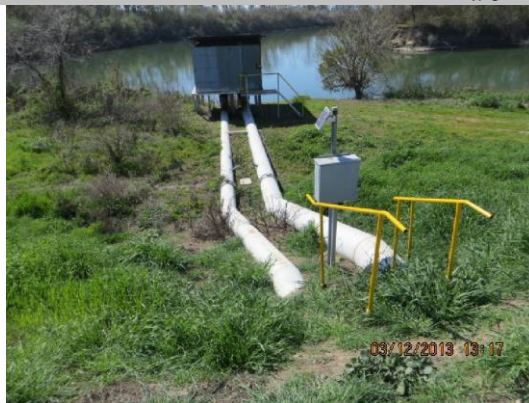
Photo 2 of 3 : UCIP\_SP\_2017\_10129\_17290.jpg

| UCIP Comments: Leak at flowmeter on WS berm may become problem in near future. | | | | | |

Pumphouse and steps on WS.

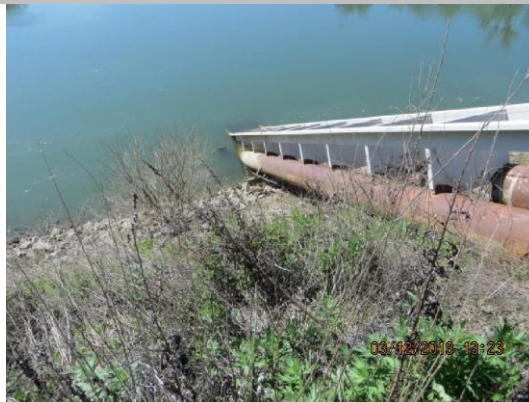
Photo 3 of 3 : UCIP\_SP\_2017\_10129\_17289.jpg

Pipe and fish screen ramp on WS.

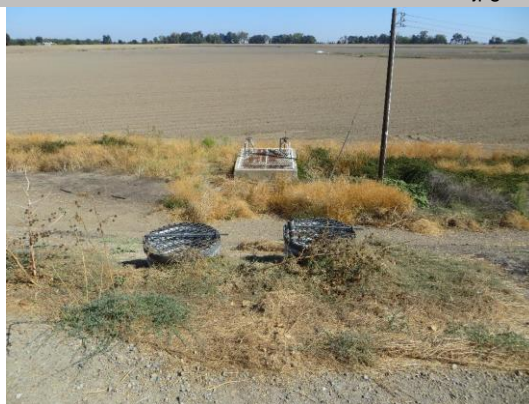
Photo 2 of 3 : UCIP\_SP\_2017\_46765\_74701.jpg

view from levee crest along pipe profile toward land side of levee. CMP risers with siphon breakers and distribution box near land side levee toe.

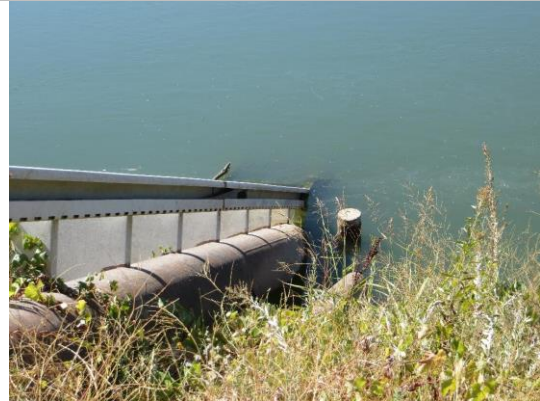
Photo 3 of 3 : UCIP\_SP\_2017\_46765\_74702.jpg

pipe intake in river. track above pipe is for drum fish screen.

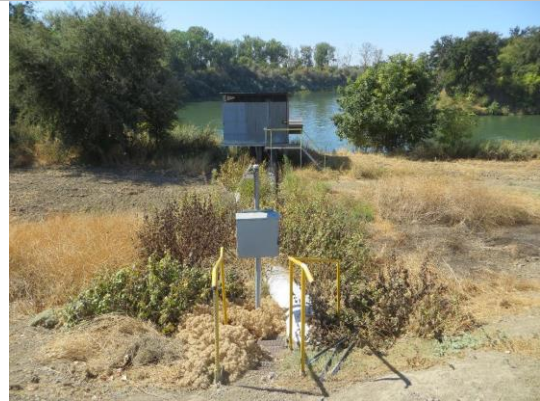
Photo 1 of 3 : UCIP\_SP\_2017\_46766\_74705.jpg

| FS_ID:46766<br>DS_ID:25126<br>EP_NO: 8501<br>Repair Type: Non-Urgent<br>Crossing Status: Found<br>UCIP Comments: a few actions are recommended based on field inspection: 1. clear out metal fence posts near daylight of pipe on water side levee. 2. clear vegetation around pipes on water side of levee to aid in inspection. 3. monitor burrowing activities on water side of levee. FIELD_STRUCT_DESC: A 20 inch steel pipe and a 16 inch steel pipe are located at levee mile 6.889 and 6.89, respectively. Both pipes have a protective paint coating. The pipes are used to supply irrigation water to the adjacent fields. On the water side of the levee, the pipes are above ground and follow the slope of the bank into the river. A metal pumphouse, supported on a steel frame is located on a bench on the waterside of the levee. When the pumps are operational a drum fish screen is lowered over the pipe intakes on a track. Both irrigation pipes travel through the levee and have siphon breakers in CMP risers on the land side crest of the levee. The pipes discharge under submerged conditions to a 9.5 ft x 12 ft concrete distribution box. There are two gated outlets on the distribution box that lead to distribution canals.<br>FS Date: 10/9/2015 | | | | | |

view from levee crest along pipe looking towards water side. shows pipe daylight and pump house

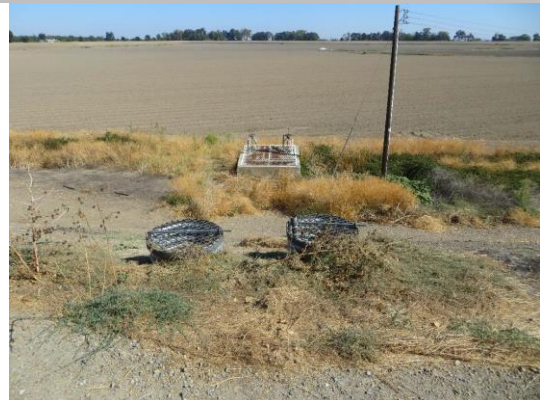
Photo 2 of 3 : UCIP\_SP\_2017\_46766\_74706.jpg

view from levee crest along pipe looking towards land side. shows siphon breaker standpipes and distribution box.

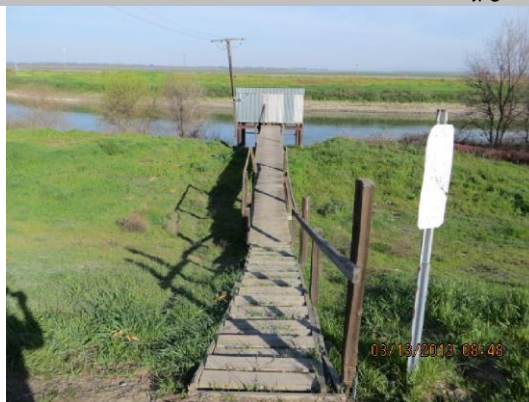
Photo 2 of 3 : UCIP\_SP\_2017\_10144\_17306.jpg

Stairs and pump on WS.

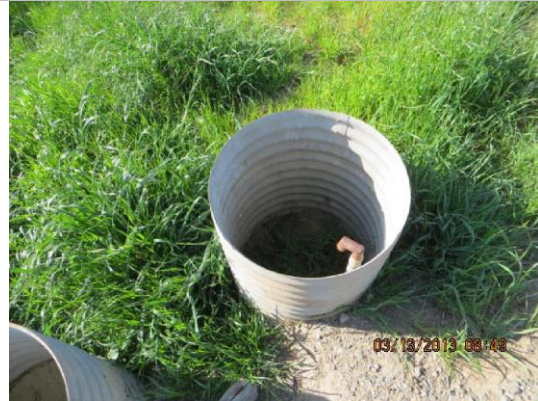
Photo 3 of 3 : UCIP\_SP\_2017\_10144\_17305.jpg

Air vent in CMP riser on LS shoulder.

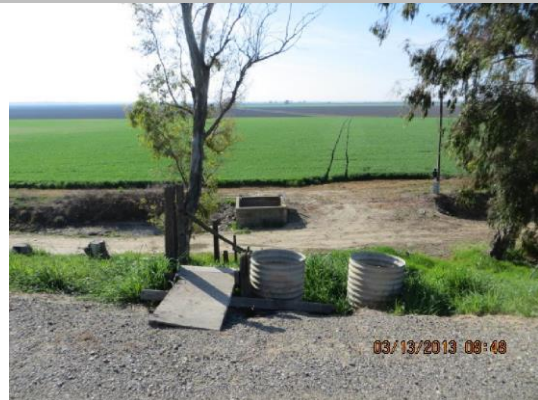
Photo 1 of 3 : UCIP\_SP\_2017\_10143\_17302.jpg

| FS_ID:10143<br>DS_ID:20427<br>EP_NO: 18206<br>Repair Type: Non-Urgent<br>Crossing Status: Found<br>UCIP Comments: Flap gates rusted through at LS distribution box.<br>FIELD_STRUCT_DESC: 2 of 2: 16-inch steel pipe through levee 4.7 feet below crown (Permit No. 18206, 2007). Two slant pumps in pump house on the waterward berm. Siphon breakers in corrugated metal riser units on the shoulder. Flap gate on both pipes in concrete distribution box on the landward side. Wooden steps on both slopes. Replaced 16-inch pipe installed under Permit No. 9377.<br>FS Date: 3/13/2013 | | | | | |

Steps, air vent in riser, and distribution box on LS.

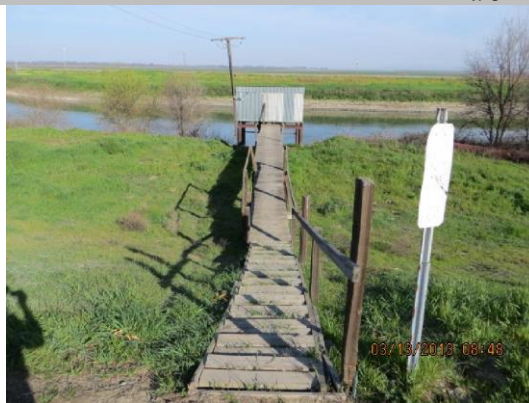
Photo 2 of 3 : UCIP\_SP\_2017\_10143\_17301.jpg

Stairs, pump platform on WS.

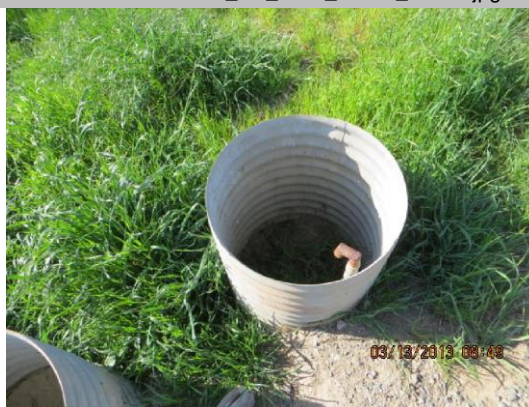
Photo 3 of 3 : UCIP\_SP\_2017\_10143\_17300.jpg

Vent in riser on LS shoulder.

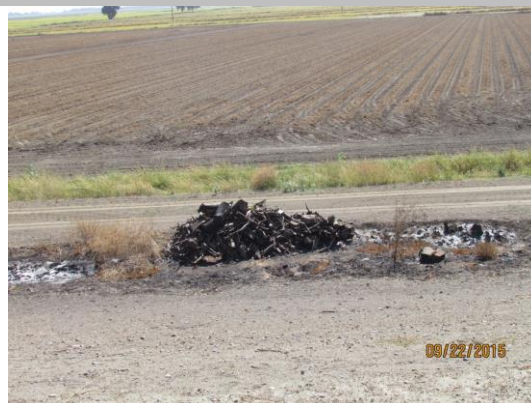
Photo 1 of 1 : SP\_2017\_NA0016\_435\_118\_20170320\_00066.jpg

View of the wood pile on the landward side of the levee. Fall 2015.

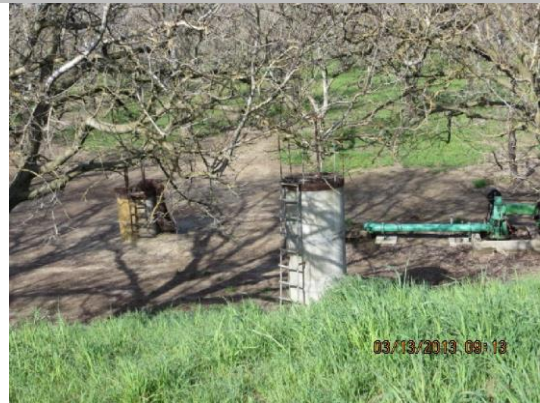
Photo 1 of 3 : UCIP\_SP\_2017\_50039\_17328.jpg

| FS_ID:50039<br>DS_ID:20231<br>EP_NO: 1641<br>Repair Type: Non-Urgent<br>Crossing Status: Found<br>UCIP Comments: 09/23/2016 - pipe is not actively used. No power to pump platform. vegetation growth obscuring view along pipe alignment on the WS toe (T.Hatch/UCIP) 09/01/2016 pipe is visible on the WS slope of the levee. The pipe appears intact on the WS and does not appear to have a meter. The siphon breaker on the LS slope appears to have been removed and replaced by a cap. No holes or missing connections were visible. WS levee slope appears to have a slight depression in the vicinity of the exposed pipe. (T. Hatch/UCIP)<br><br>03/13/2013 - Meter removed from the pipe on the WS and pipe is open. Pipe appears abandoned, and, if so, should be abandoned properly. (W. Wylie/UCIP)<br>FIELD_STRUCT_DESC: *ABANDONED* 14-inch steel irrigation pipe through the levee, 5.2 feet below the crown. A slant pump on a concrete pump platform on the waterside (WS). A siphon breaker on the landside (LS) slope. A sparring flow meter on the pipe on the WS slope. 42 inch concrete standpipe in concrete distribution box at the landside (LS) toe. (Permit No. 1641, 1959 - Erdman). [Additional Reference(s): DWR Levee Logs, 2006. USACE Sacramento O&M Manual 130, May 1960 (LM 9.31)].<br>FS Date: 9/23/2016 | | | | | | |

Concrete riser on LS toe.

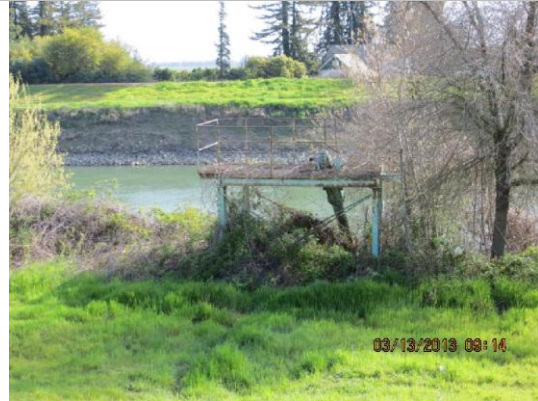
Photo 2 of 3 : UCIP\_SP\_2017\_50039\_17327.jpg

Pump platform on WS.

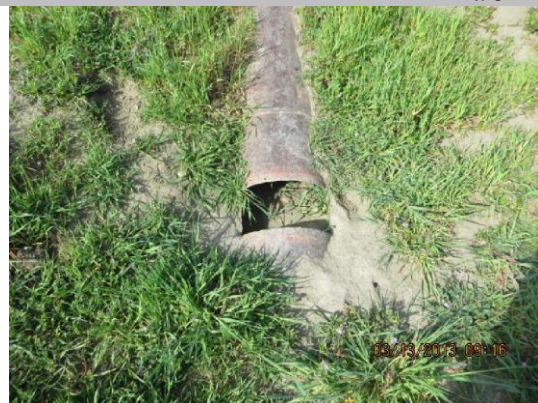
Photo 3 of 3 : UCIP\_SP\_2017\_50039\_17326.jpg

Pipe open where watermeter was removed.

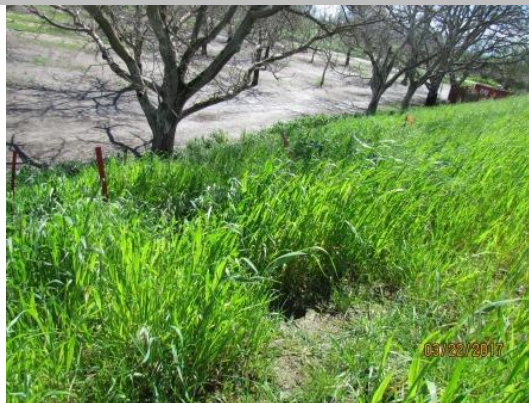
Photo 1 of 1 : SP\_2017\_NA0016\_435\_226\_20170417\_00340.jpg

| Rodent burrow on landside levee slope. | | | | | |

Rodent burrow on landside levee slope. Spring 2017.

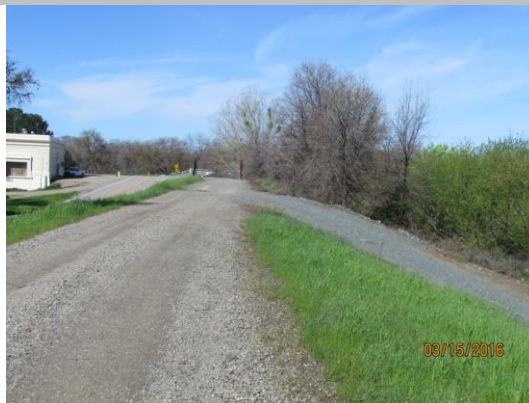
Photo 1 of 2 : SP\_2017\_NA0016\_435\_29\_20170320\_00021.jpg

View of the revegetation site on the waterward side of the levee looking upstream. Spring 2016.

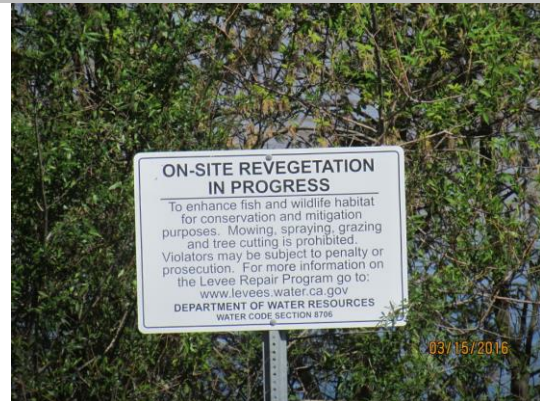
Photo 2 of 2 : SP\_2017\_NA0016\_435\_29\_20170320\_00022.jpg

Revegetation site sign. Spring 2016.

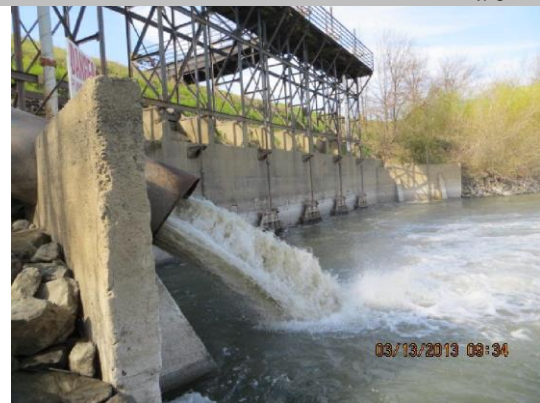
Photo 1 of 3 : UCIP\_SP\_2017\_10163\_17342.jpg

Pipe at outlet on WS toe.

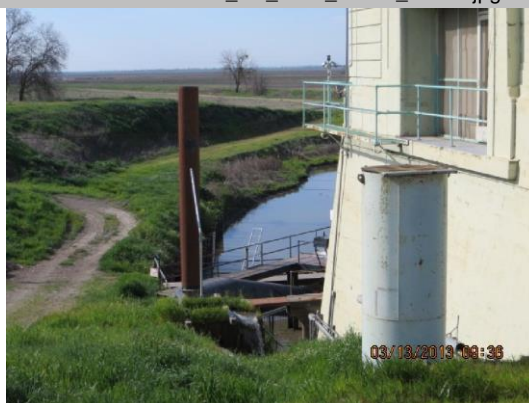
Photo 2 of 3 : UCIP\_SP\_2017\_10163\_17341.jpg

12-inch steel standpipe at LS toe with 36-inch steel riser.

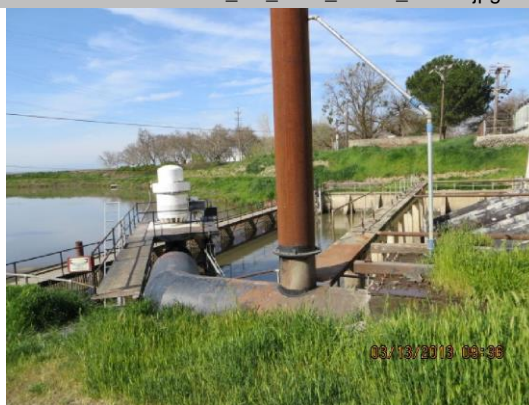
Photo 3 of 3 : UCIP\_SP\_2017\_10163\_17340.jpg

Pump on platform at LS toe.

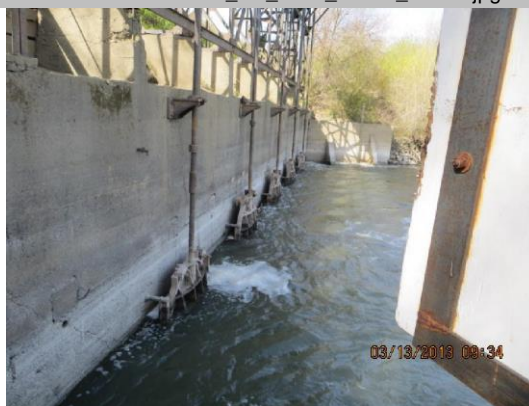
Photo 1 of 3 : UCIP\_SP\_2017\_10164\_17345.jpg

Slide gates at concrete headwall at river

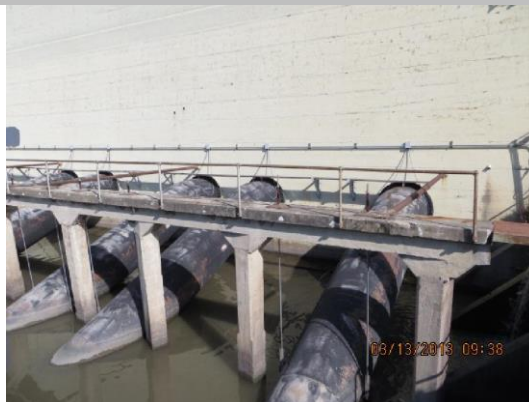
Photo 2 of 3 : UCIP\_SP\_2017\_10164\_17344.jpg

Pipes at entrance to pumping plant building on LS toe.

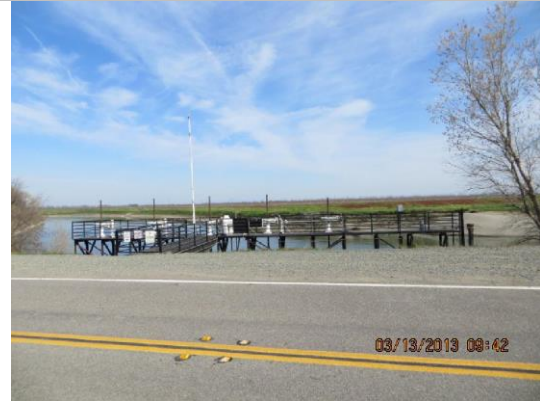
Photo 3 of 3 : UCIP\_SP\_2017\_10164\_17343.jpg

Slide gate actuators on WS shoulder.

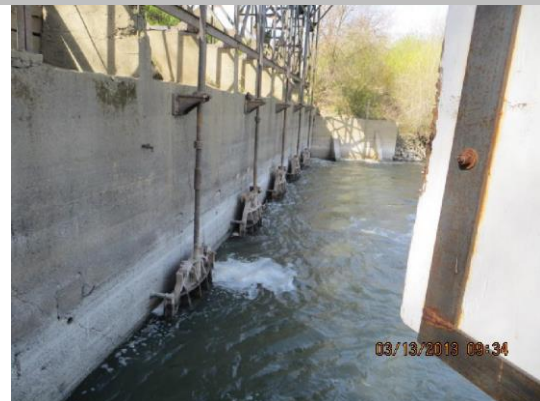
Photo 1 of 3 : UCIP\_SP\_2017\_10165\_17348.jpg

Slide gates and headwall on WS toe.

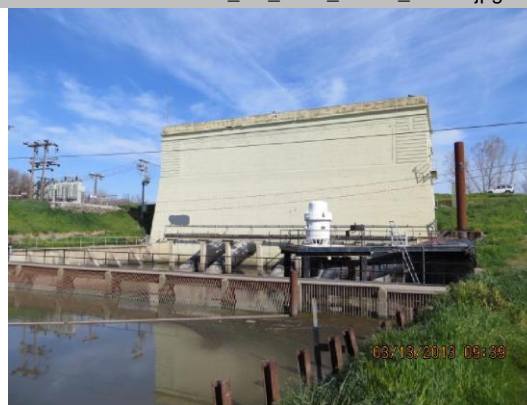
Photo 3 of 3 : UCIP\_SP\_2017\_10165\_17346.jpg

Pumphouse on LS.

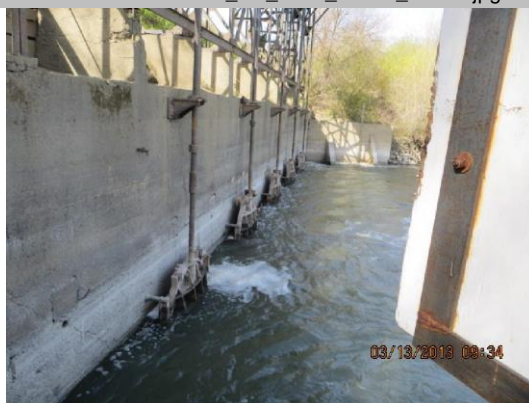
Photo 1 of 3 : UCIP\_SP\_2017\_10168\_17360.jpg

Slide gate and concrete headwall on WS toe.

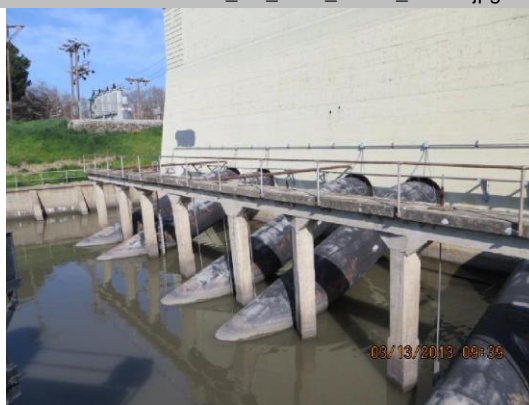
Photo 2 of 3 : UCIP\_SP\_2017\_10168\_17359.jpg

Pipe at inlet to pump house on LS toe.

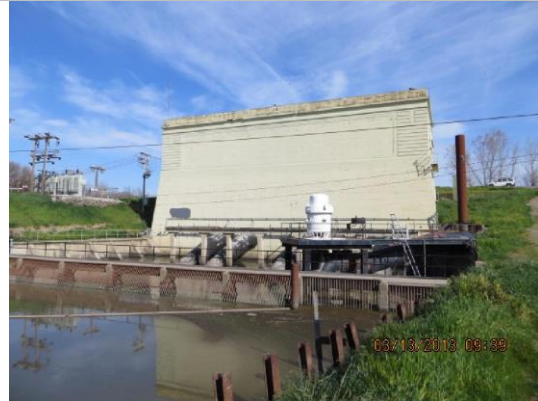
Photo 3 of 3 : UCIP\_SP\_2017\_10168\_17358.jpg

Pumphouse on LS.

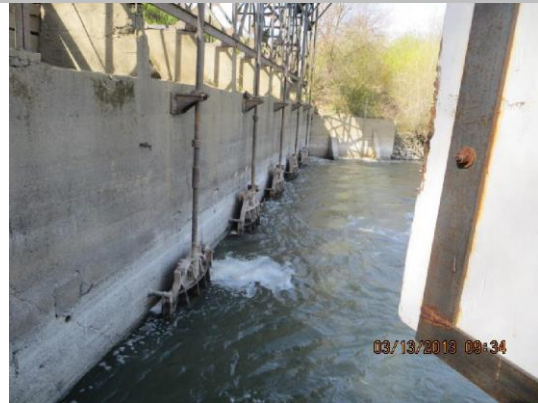
Photo 1 of 3 : UCIP\_SP\_2017\_10167\_17352.jpg

Slide gates and headwall at WS toe.

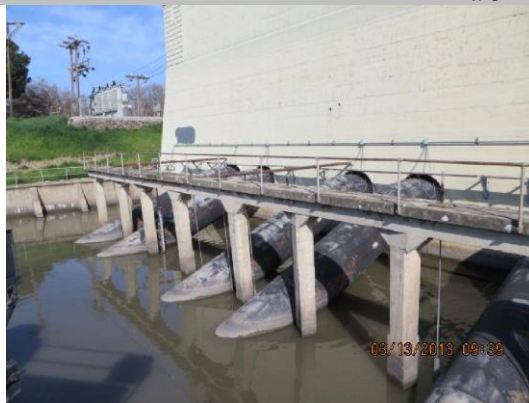
Photo 2 of 3 : UCIP\_SP\_2017\_10167\_17351.jpg

Pipes at inlet to pumping plant on LS toe.

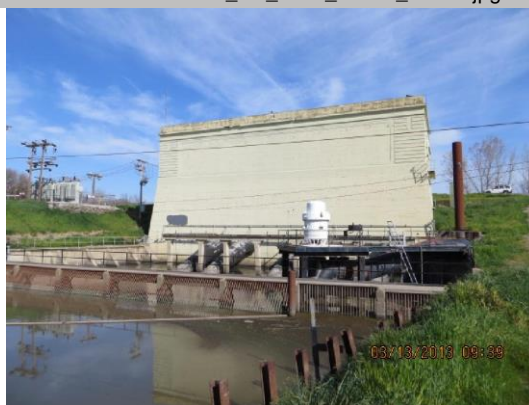
Photo 3 of 3 : UCIP\_SP\_2017\_10167\_17350.jpg

Pumping plant on LS.

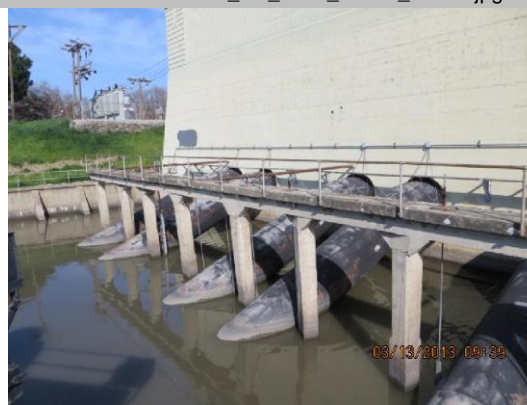
Photo 2 of 3 : UCIP\_SP\_2017\_10169\_17363.jpg

pipes at entrance to pump house on LS toe.

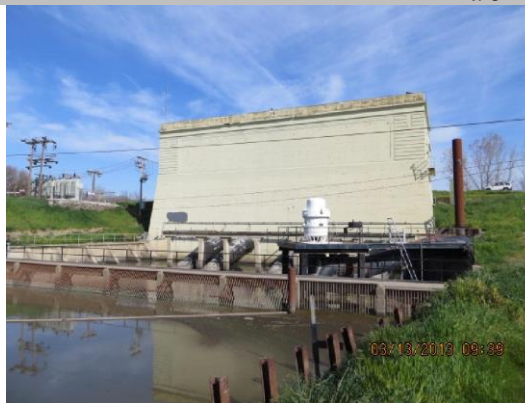
Photo 3 of 3 : UCIP\_SP\_2017\_10169\_17362.jpg

Pumphouse on LS.

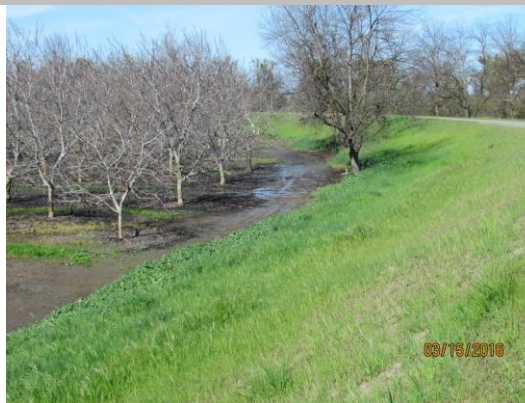
Photo 1 of 2 : SP\_2017\_NA0016\_435\_161\_20170320\_00085.jpg

View of the seepage on the landward side of the levee looking upstream. Spring 2016.

| Seepage area has been staked and noted by LMA. Monitor seepage site. | | | | | |

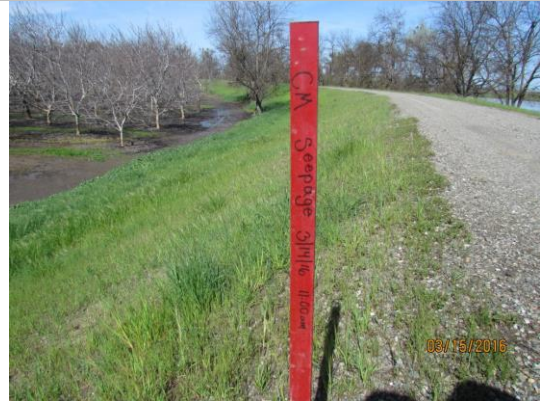
Photo 2 of 2 : SP\_2017\_NA0016\_435\_161\_20170320\_00086.jpg

Stake shows LMA is monitoring the seepage. Spring 2016.

| Seepage area has been staked and noted by LMA. Monitor seepage site. | | | | | | |

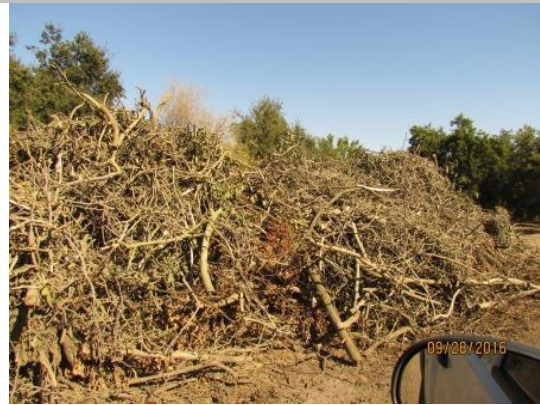
Photo 1 of 1 : SP\_2017\_NA0016\_435\_122\_20170320\_00068.jpg

Tree prunings on WS slope. Fall 2016 inspection.

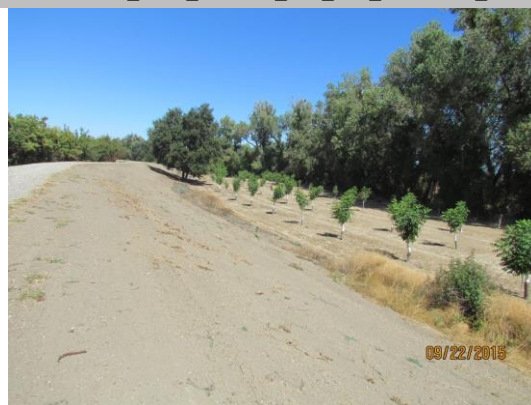
Photo 1 of 1 : SP\_2017\_NA0016\_435\_966\_20170320\_00112.jpg

| New walnut orchard between toe and river with approximately 80-90 trees. | | | | | |

View of the walnut orchard planted on the waterward side of the levee looking upstream. Fall 2015.

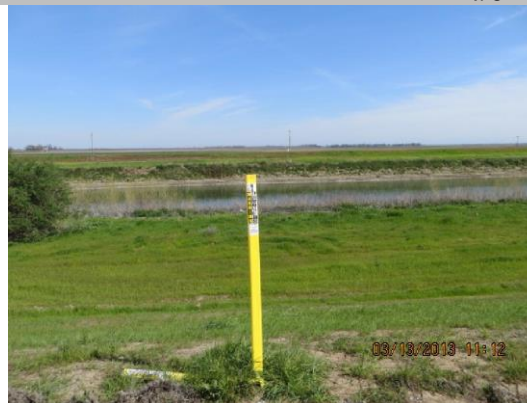
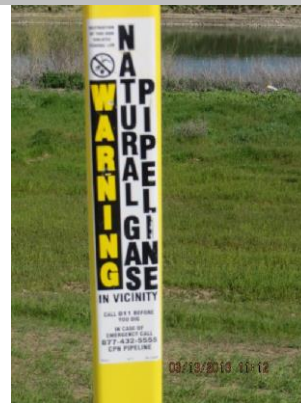
Photo 1 of 2 : UCIP\_SP\_2017\_10203\_17399.jpg

| UCIP Comments: Need to determine if this is a permitted crossing as it was not previously noted. Need to determine size and depth below the crown. | | | | | |

Gasline marker on WS shoulder.

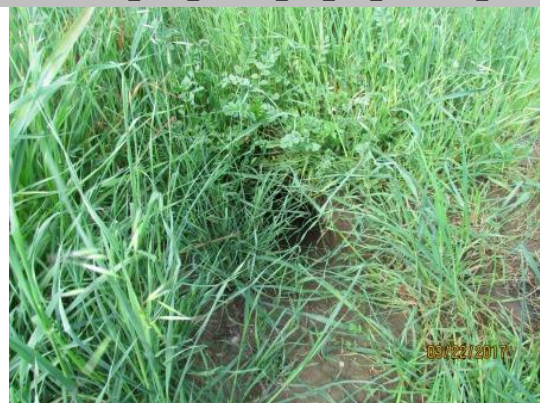
Photo 1 of 1 : SP\_2017\_NA0016\_435\_233\_20170417\_00341.jpg

| Rodent burrow on landside levee slope. | | | | | |

Rodent burrow on landside levee slope. Spring 2017.

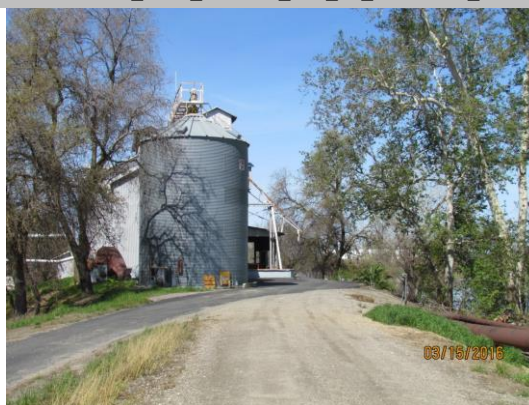
Photo 1 of 1 : SP\_2017\_NA0016\_435\_16\_20170320\_00015.jpg

View of the rice mill on the crown of the levee looking upstream. Spring 2016.

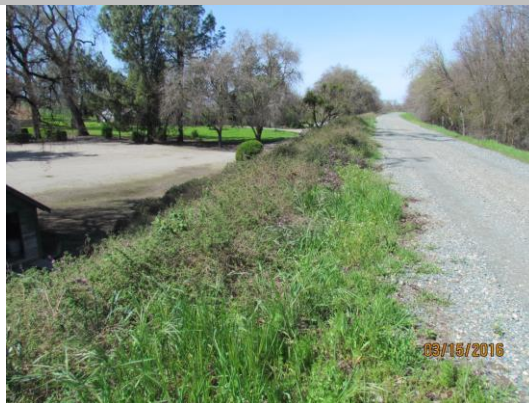
Photo 1 of 2 : SP\_2017\_NA0016\_435\_173\_20170320\_00091.jpg

View of the landscaping on the landward side of the levee looking upstream. Spring 2016.

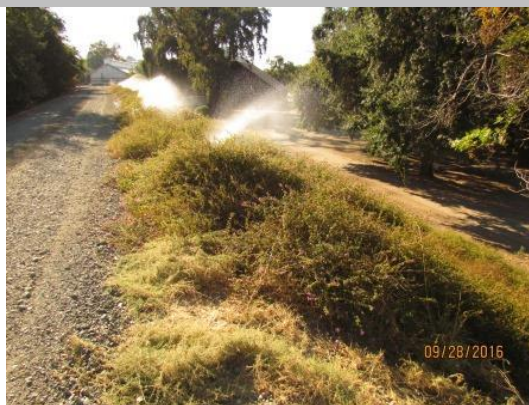
Photo 2 of 2 : SP\_2017\_NA0016\_435\_173\_20170320\_00092.jpg

Irrigated landscaping on landside slope of the levee reaching levee crown. Fall 2016 inspection.

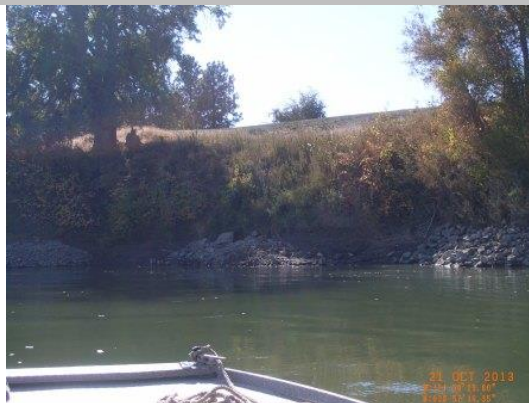
Photo 1 of 1 : SP\_2017\_NA0016\_435\_10\_20170320\_00010.jpg

| 2009 - Minor erosion, should be repaired under maintenance. 2011 - Some new minor erosion at the toe. 2015: No observed changes. [2015 Site ID: SAC_111-0_R] | | | | | |

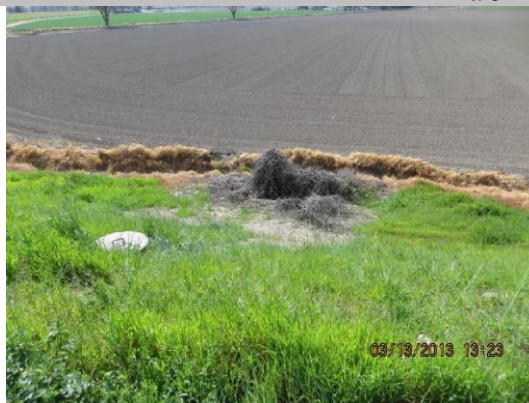
Photo 1 of 2 : UCIP\_SP\_2017\_10253\_17449.jpg

| FS_ID:10253<br>DS_ID:20246<br>EP_NO: 1507<br>Repair Type: Non-Urgent<br>Crossing Status: Found<br>UCIP Comments: Pipe appears abandoned. Needs to be abandoned properly.<br>FIELD_STRUCT_DESC: 14-inch steel irrigation pipe through levee 8.4 feet below crown. Gate valve on the waterward side, siphon breaker in 24-inch CMP riser on the landward slope. Concrete distribution box in irrigation ditch at the toe of the landward slope (Permit No. 1507, 1959). Included in the 1960 O&M manual.<br>FS Date: 3/13/2013 | | | | | |

CMP Riser on shoulder and concrete distribution box under heavy blackberry cover at LS toe.

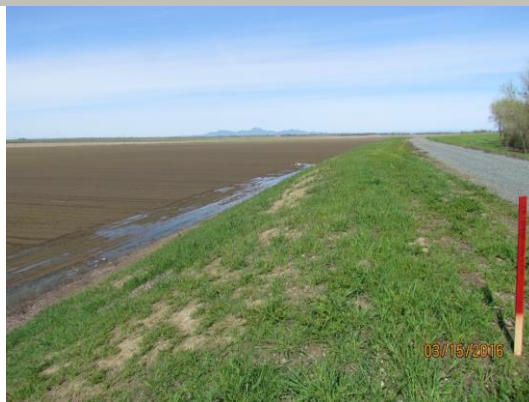
Photo 1 of 2 : SP\_2017\_NA0016\_435\_176\_20170320\_00093.jpg

View of the seepage on the landward side of the levee looking upstream.  
Spring 2016.

| Seepage area has been staked and noted by LMA. Monitor seepage site. | | | | | |

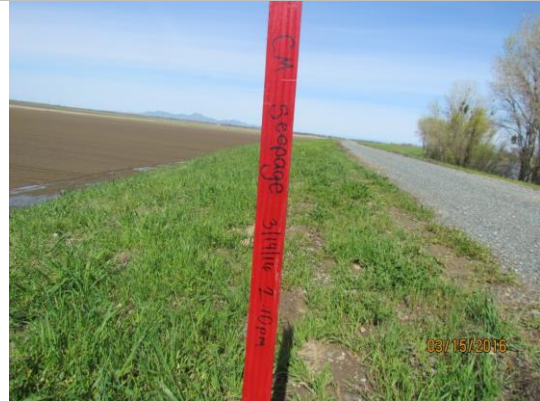
Photo 2 of 2 : SP\_2017\_NA0016\_435\_176\_20170320\_00094.jpg

Monitoring stake for the seepage. Spring 2016.

| Seepage area has been staked and noted by LMA. Monitor seepage site. | | | | | | |

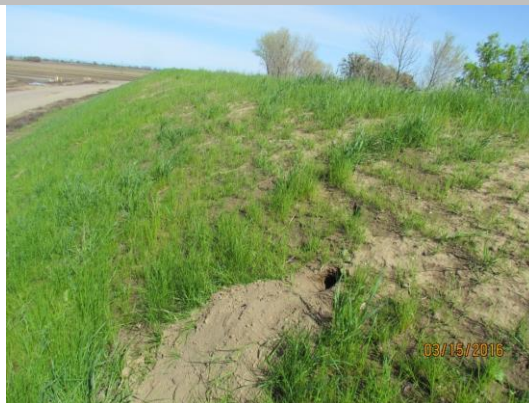
Photo 1 of 1 : SP\_2017\_NA0016\_435\_179\_20170320\_00095.jpg

View of the rodent hole on the landward side of the levee looking upstream. Spring 2016.

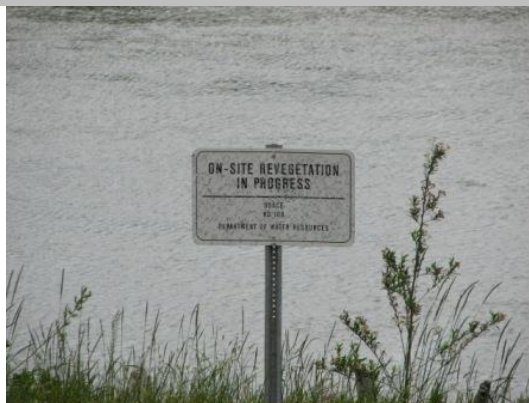
Photo 1 of 2 : SP\_2017\_NA0016\_435\_30\_20170320\_00023.jpg

Revegetation site. Photo taken spring 2012.
